Florida Turnpike Enterprise Bridge Inspection at Lake Jessup

SUMMARY

In 2014, NEXCO-West USA worked with the Florida Turnpike Enterprise for research purposes. Lake Jessup's bridge condition assessment was performed with the goal of evaluating NEXCO's digital imaging and infrared (IR) technology capabilities.

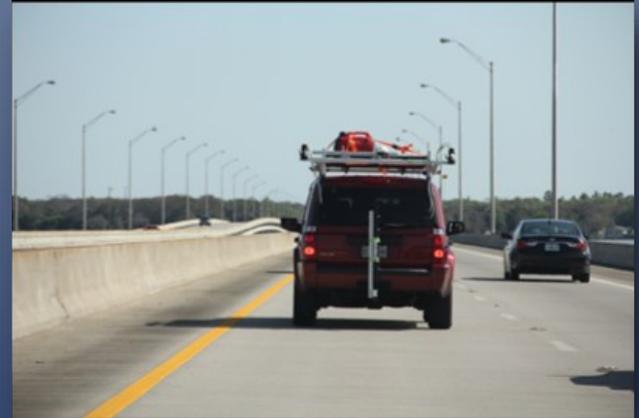
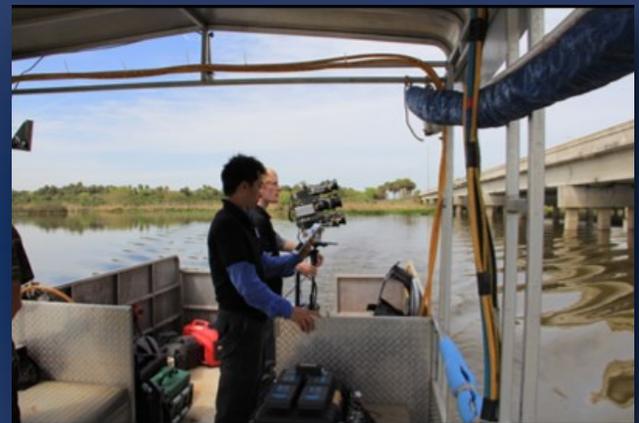
In order to detect surface and subsurface indications within the concrete structure for the bridge deck, railings, and beams; two different strategies were employed. The element condition state for the reinforced concrete deck was determined based on the information collected by the vehicle-mounted cameras at a speed of 50 mph. The condition state for reinforced concrete bridge railings and prestressed concrete beams were determined based on the information collected from a stationary system placed on a pontoon boat.
