# Pearl Harbor Memorial Bridge Comprehensive Crack Mapping

## SUMMARY

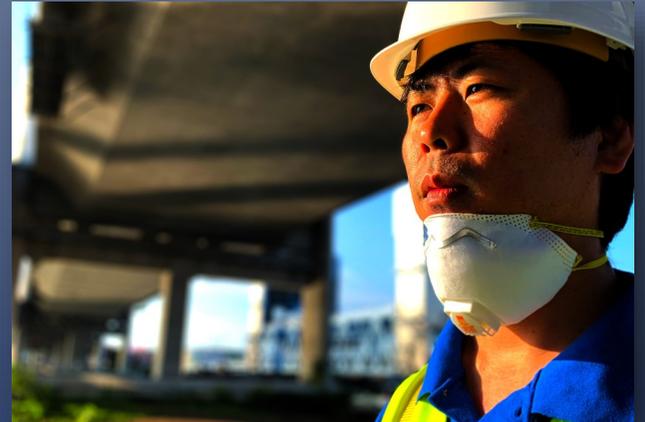
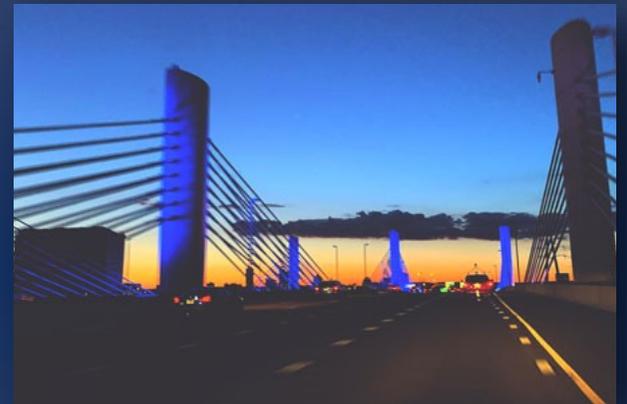
NEXCO undertook this task and provided the owners with a comprehensive visual and infrared scan of each surface type, including deck top, underside, box girder interior/exterior, and pier tower interior/exterior. Cracks with widths greater than 0.3mm in all areas, 0.1mm in some areas, were reported on in visual deficiency maps and numerical summary tables.
